TAT ACTIVITIES REPORT
PRELIMINARY SITE ASSESSMENT
STANDARD STEEL AND METALS SALVAGE YARD
ANCHORAGE, ALASKA

28 OCTOBER - 8 NOVEMBER 1985

Prepared by
Region X
Technical Assistance Team
TDD #10-8510-07

For
Region X
Environmental Protection Agency

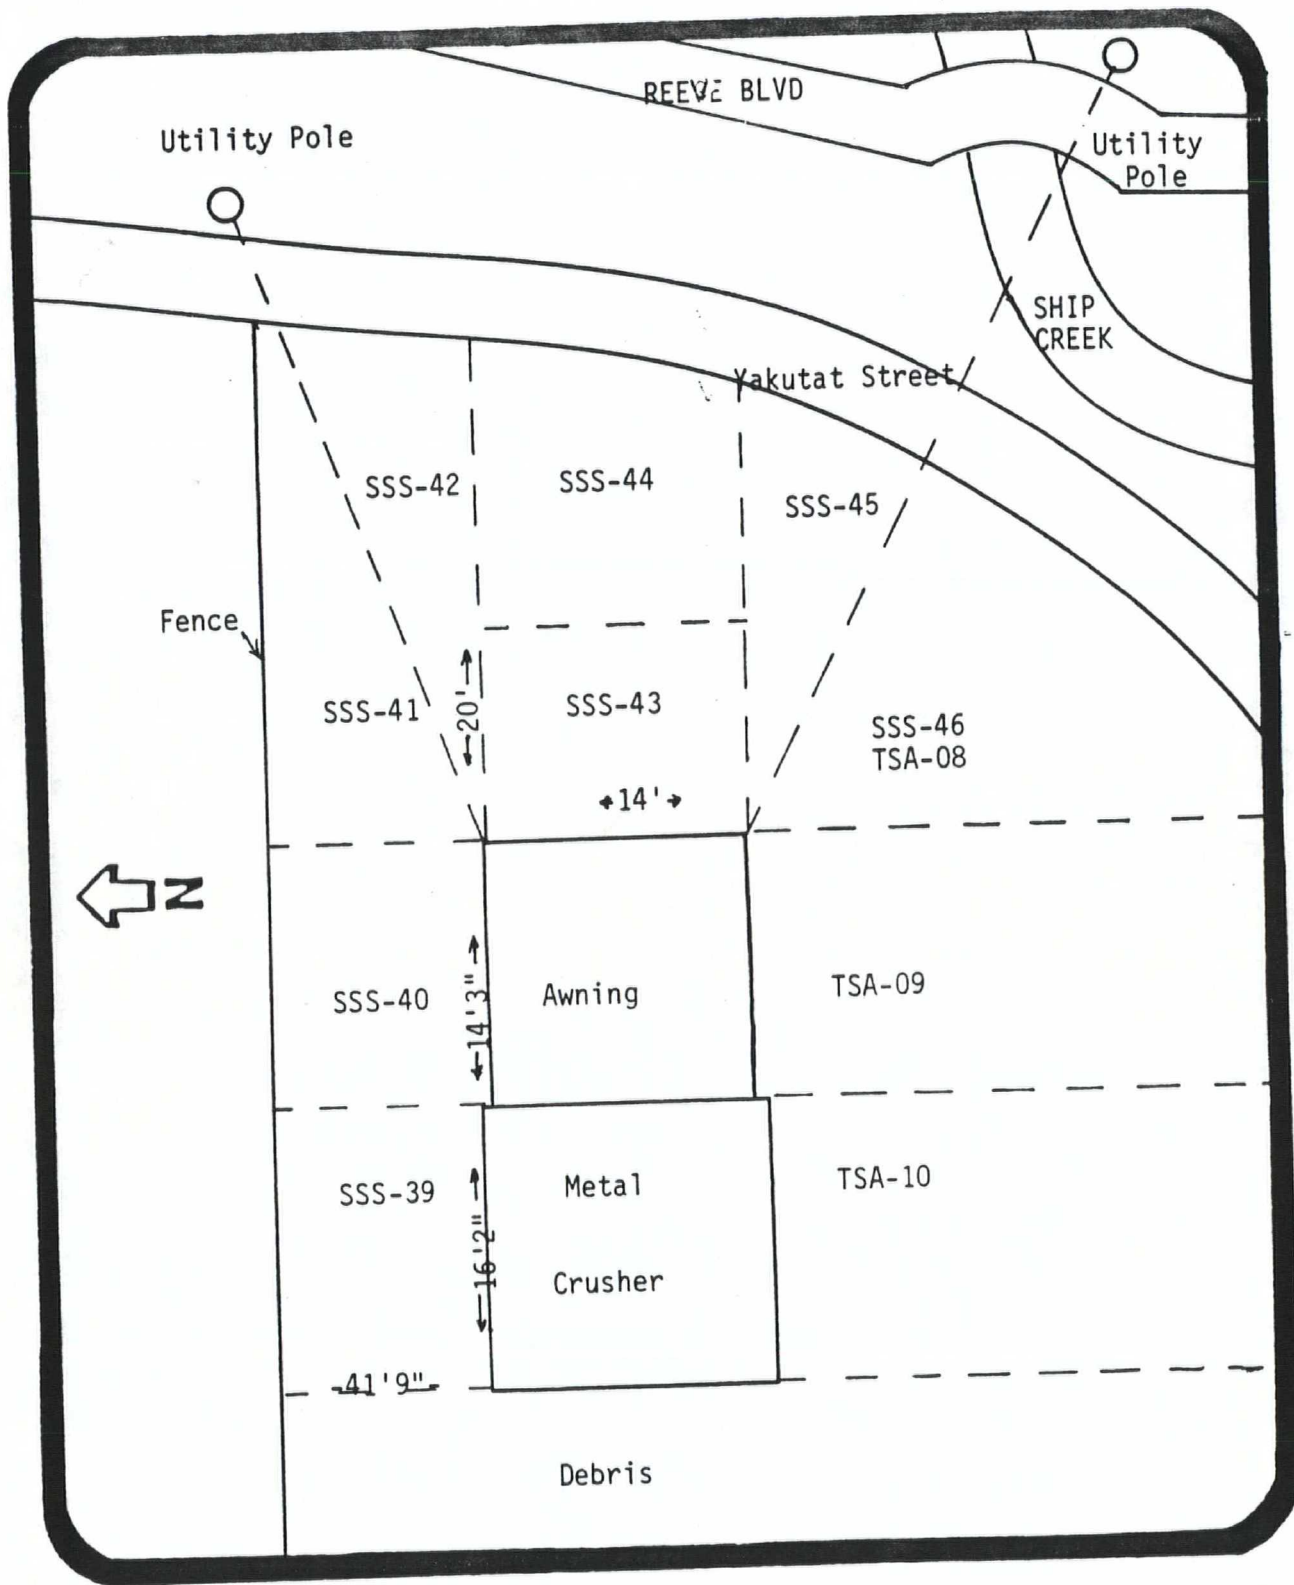
Figure 3

- o Transformer Storage Area #1 - A grid sampling network was set up for the collection of composite soil samples from this area (Figure 3), and 11 composite soil samples were collected for PCB analysis. One sample was also analyzed for carrier solvents, phenols, and heavy metals. The ADEC samples which indicated 110,000 and 87,000 ppm PCB had been collected from this area. TAT personnel attempted to collect soil from each oil-stained area of soil within a section; however, the majority of the soil in the area appeared to be oil-stained.
- o Transformer Storage Area #2 - Two composite soil samples were collected from transformer storage area #2. The distance from the roadway (which forms the northern boundary of this area) to the fence (which forms the southern boundary) was divided in half and a composite sample was col-

Sampling Grid
Main Transformer Storage Area
Standard Steel, Anchorage, Alaska

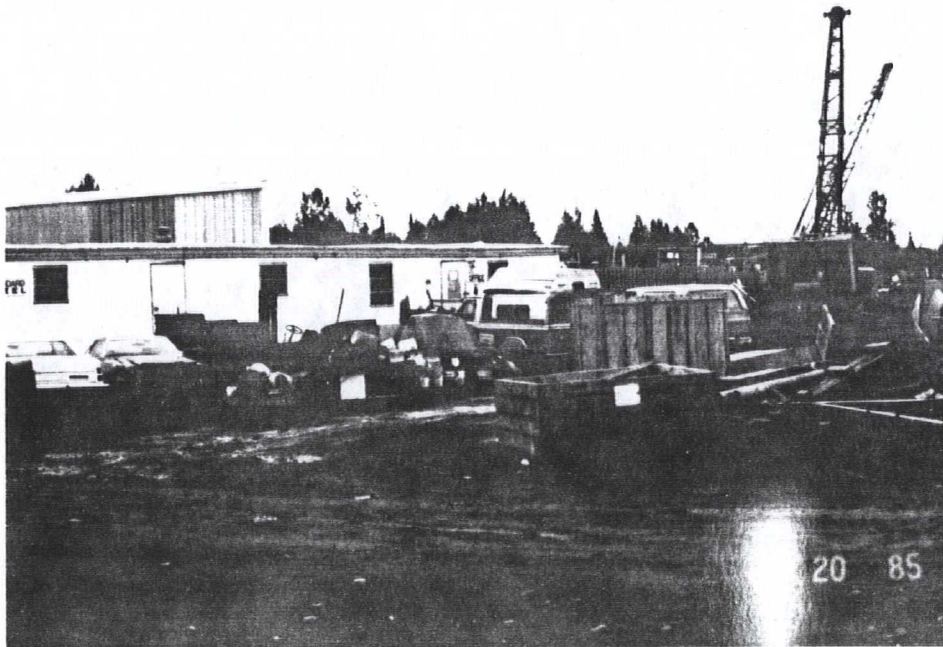
Photo 2. Facing north up Yakutat Avenue, which borders the east side of the site.

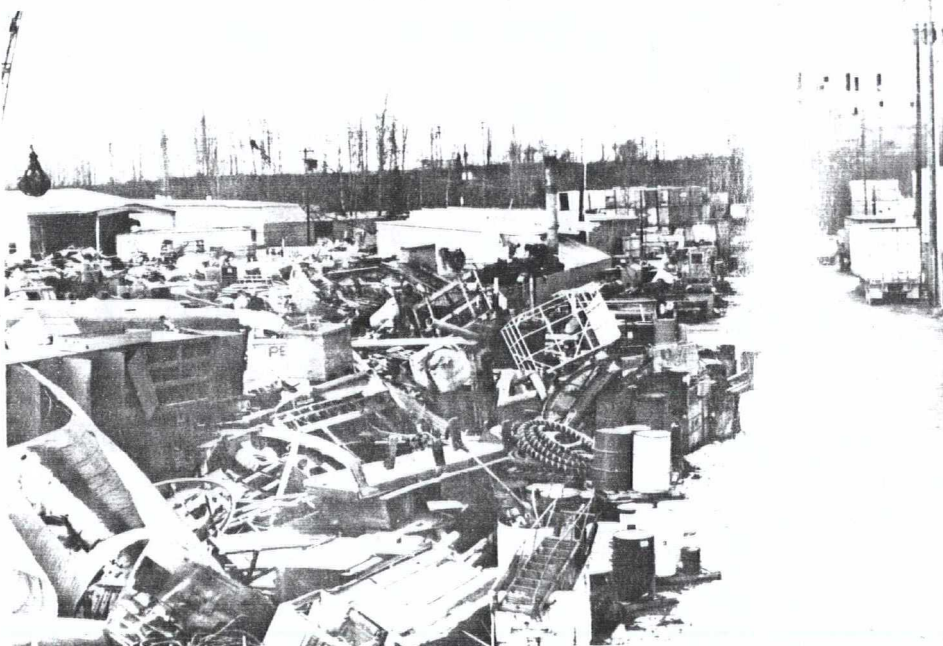
Photo 3. The Standard Steel site facing northwest. The main transformer storage area can be seen in the area behind the blue truck. The hydraulic metal crusher is just to the right of the large storage van displaying the orange stripe.

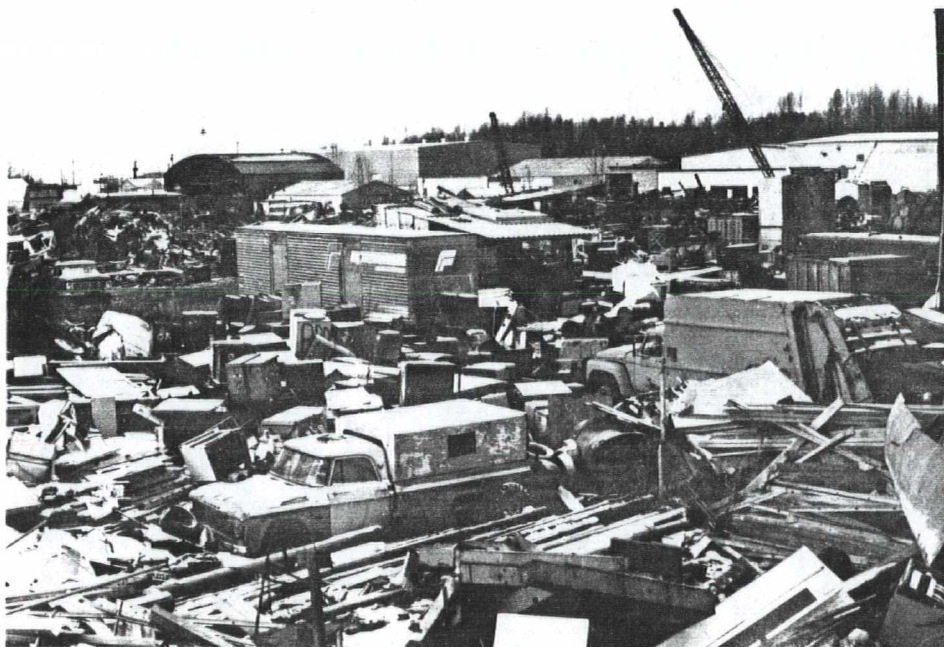
Photo 4. The Standard Steel site facing west. Transformer storage area #2 is seen in the left side of the photo. Downtown Anchorage office buildings can be seen in the background. It can be noted from this photo how most of the ground at the site is covered with metal debris. The open pathway is the most frequented roadway on the site.

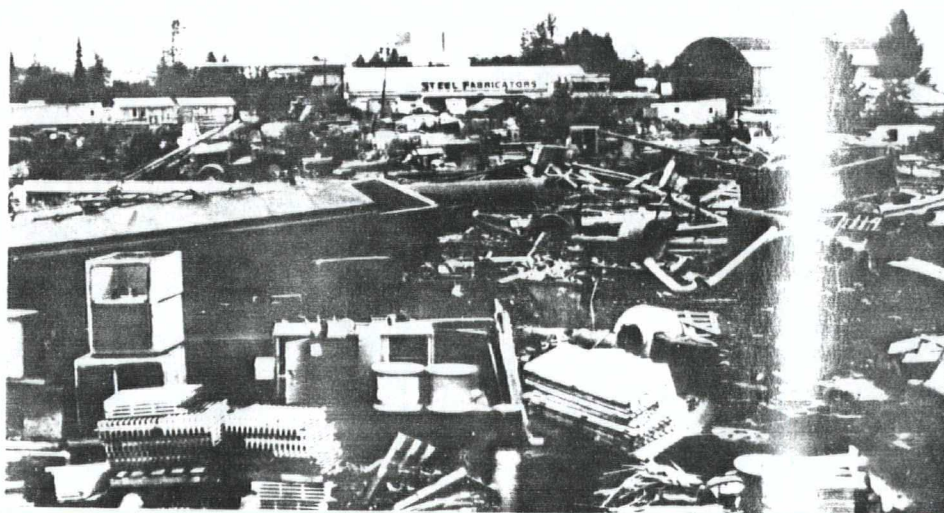
Photo 5. It is estimated that over 20,000 batteries are located on the site, and many are leaking. Several piles as large as this are located throughout the site.

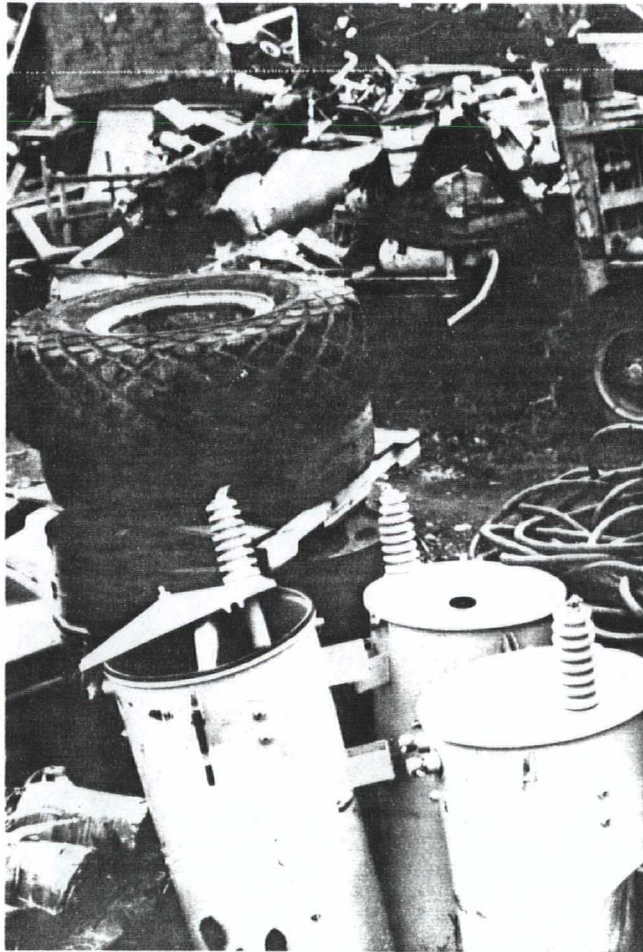
Photo 8. The main transformer storage area. Transformers marked with an "OK" were previously tested by ADEC personnel and were determined to contain less than 50 ppm PCB.

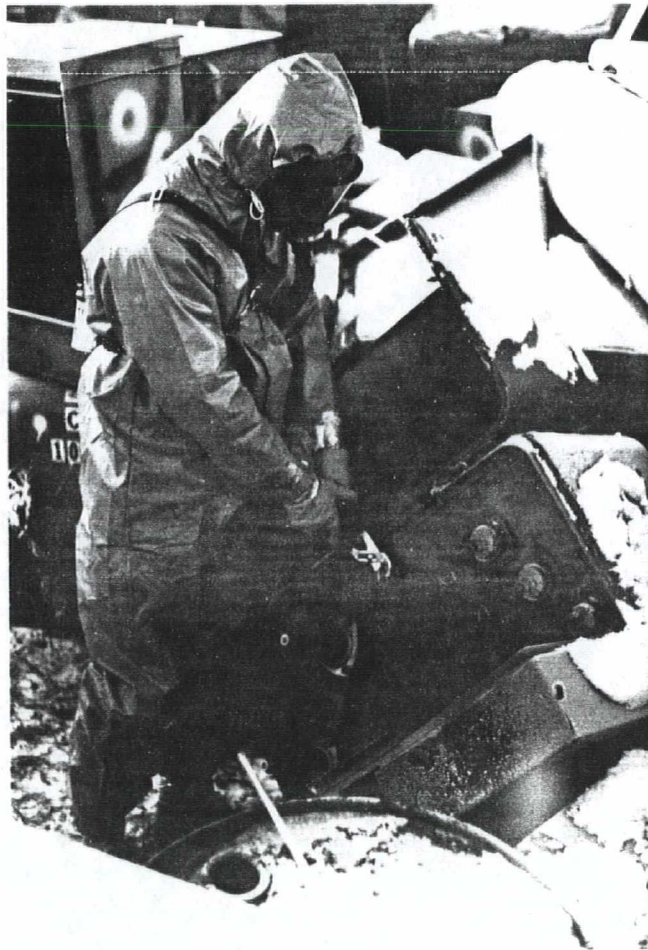
Photo 12. TAT personnel sampling a transformer in TSA #1.

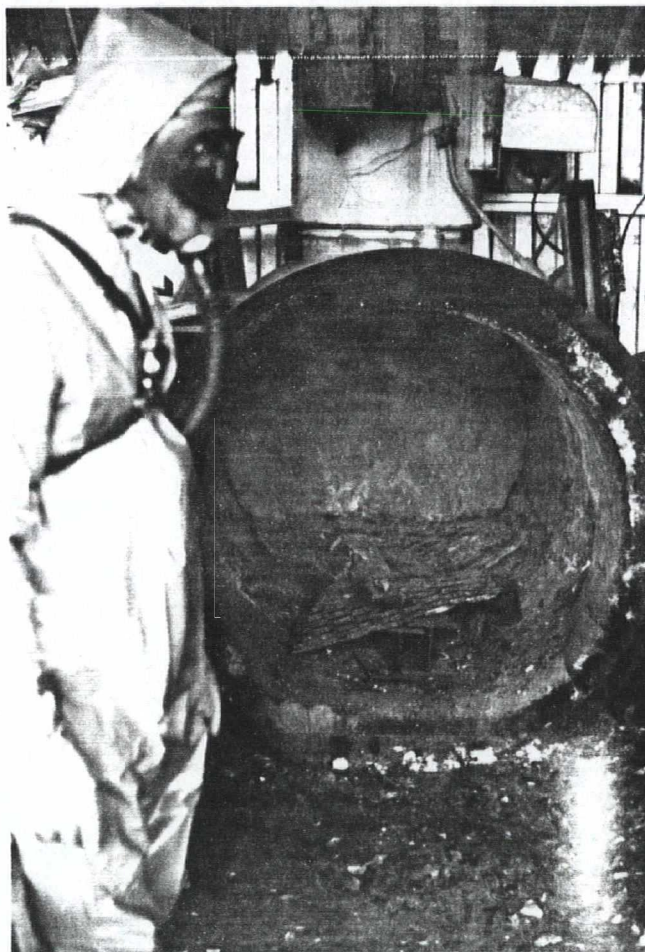
Photo 24. Ash from inside the incinerator.
